Roof Revival In The Deep South

Candy Distributor Gets Sweet Deal With TOPPS SEAL™

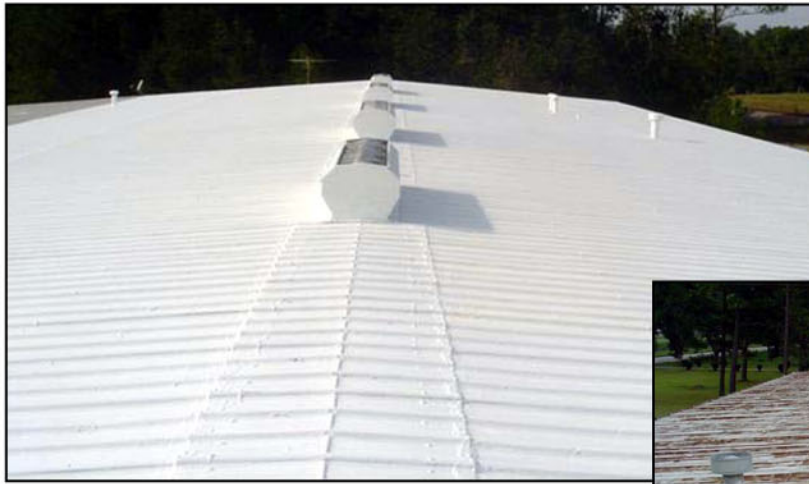
The brilliant white finished roof (left) reflects harmful UV rays, cooling building interior in summer months. Special care was taken to remove all previous coatings and rust (below) prior to beginning TOPPS® renewal.

The finished roof is not only beautiful, but energy-efficient in reflective white. Leaks are a thing of the past with the 600% elongation TOPPS SEAL EXCEL™ rubber provides.

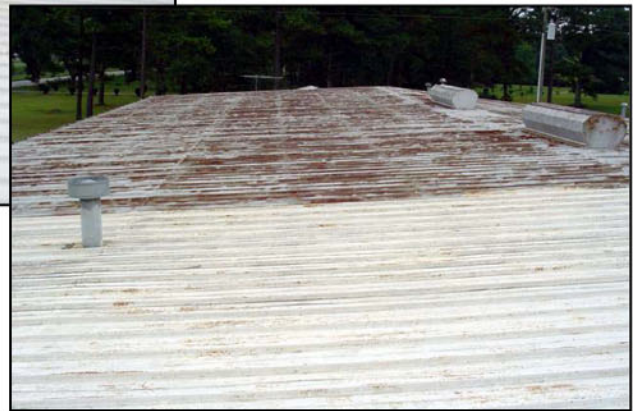
Seldom are results of total restoration so apparent as with this project. The process corrected 10 leaks and returned this 25 year-old roof to new performance in under 10 days.

Maintenance once again proved effective. The roof was 100% rusted on the surface. Only four isolated areas required replacement, before the process began to the otherwise sound metal.

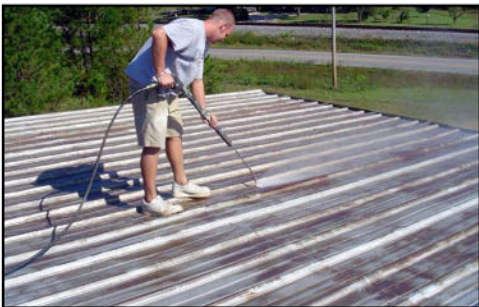
High-pressure water was used to blast off all remaining previous coatings, dirt, and loose rust particles.

The use of RUSTARRESTOR™ enabled two men equipped with two high-pressure washers to totally remove all surface rust and prepare the surface within 5 days. After 3 days, the seamless TOPPS SEAL™ installation was completed with all fasteners and seams locked into place beneath RIVETGUARD™.

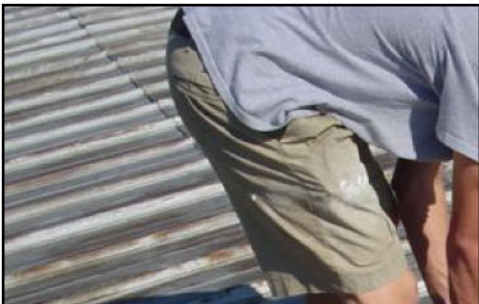
All fasteners were checked, and tightened or replaced before repairs began.
